# **COMPARATIVE STUDY OF LEAKAGE CURRENT ON INSULATION SURFACE CONDITION**

**MUHAMAD SYAKIR BIN KAMIS**

**A report submitted in partial fulfillment of the requirements for the degree of Bachelor of  
Electrical Engineering (Industrial Power)**

**UNIVERSITI TEKNIKAL MALAYSIA MELAKA**

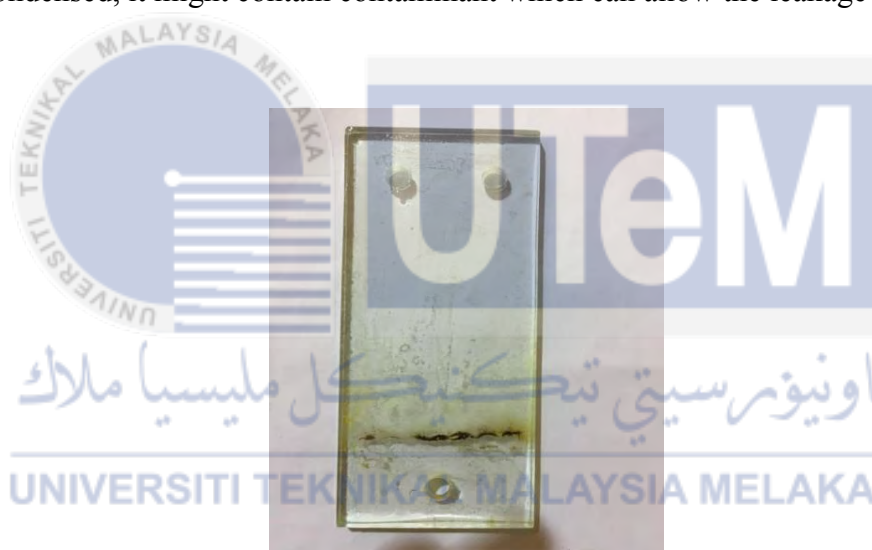
Figure 2.1: Glass Specimen

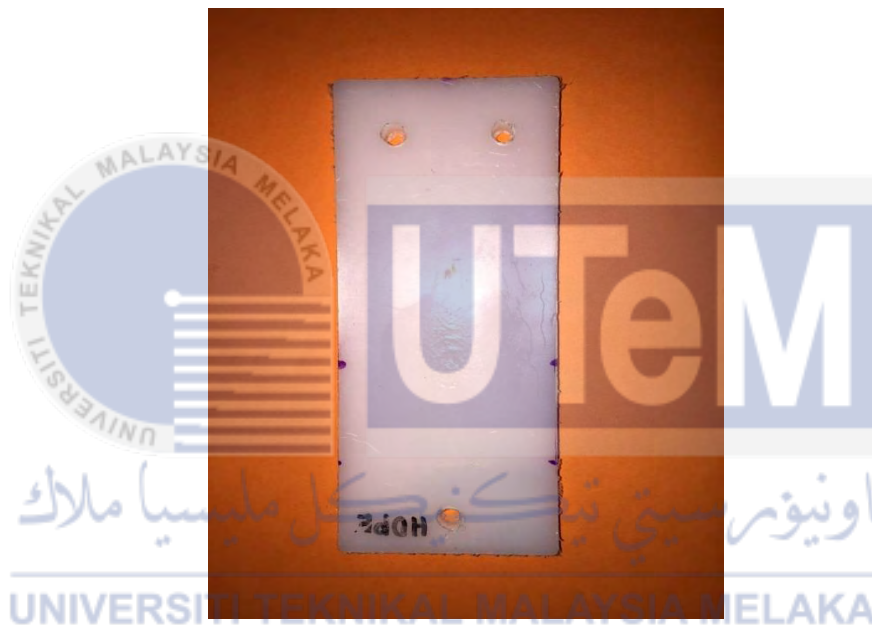
Figure 2.3: High Density Polyethylene (HDPE) Specimen

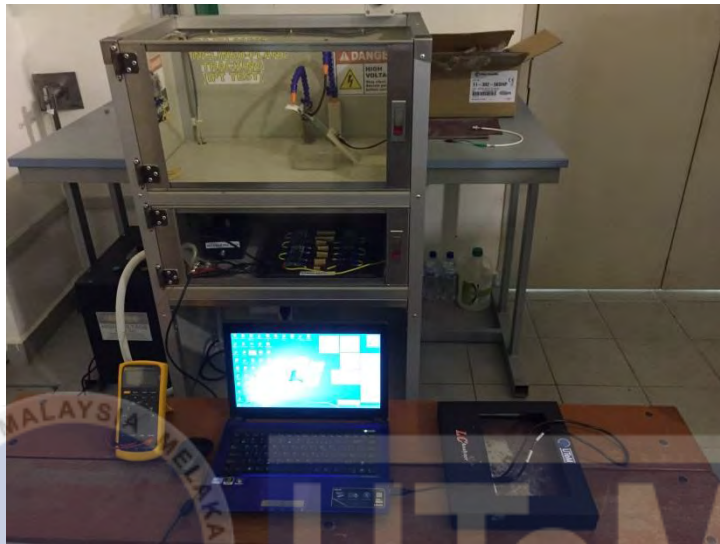
Figure 3.1: The Incline Plane Tracking Test Set-Up

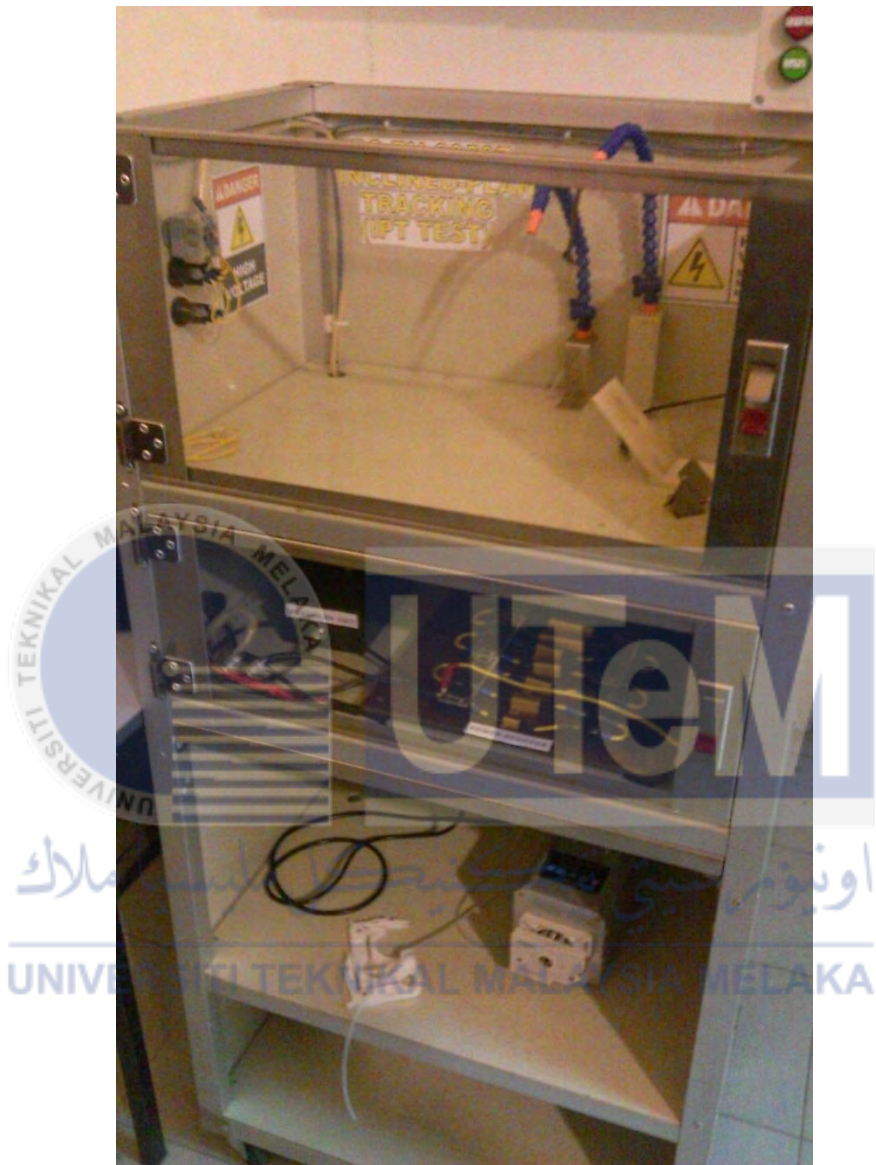
Figure A: Incline Plane Test Setup

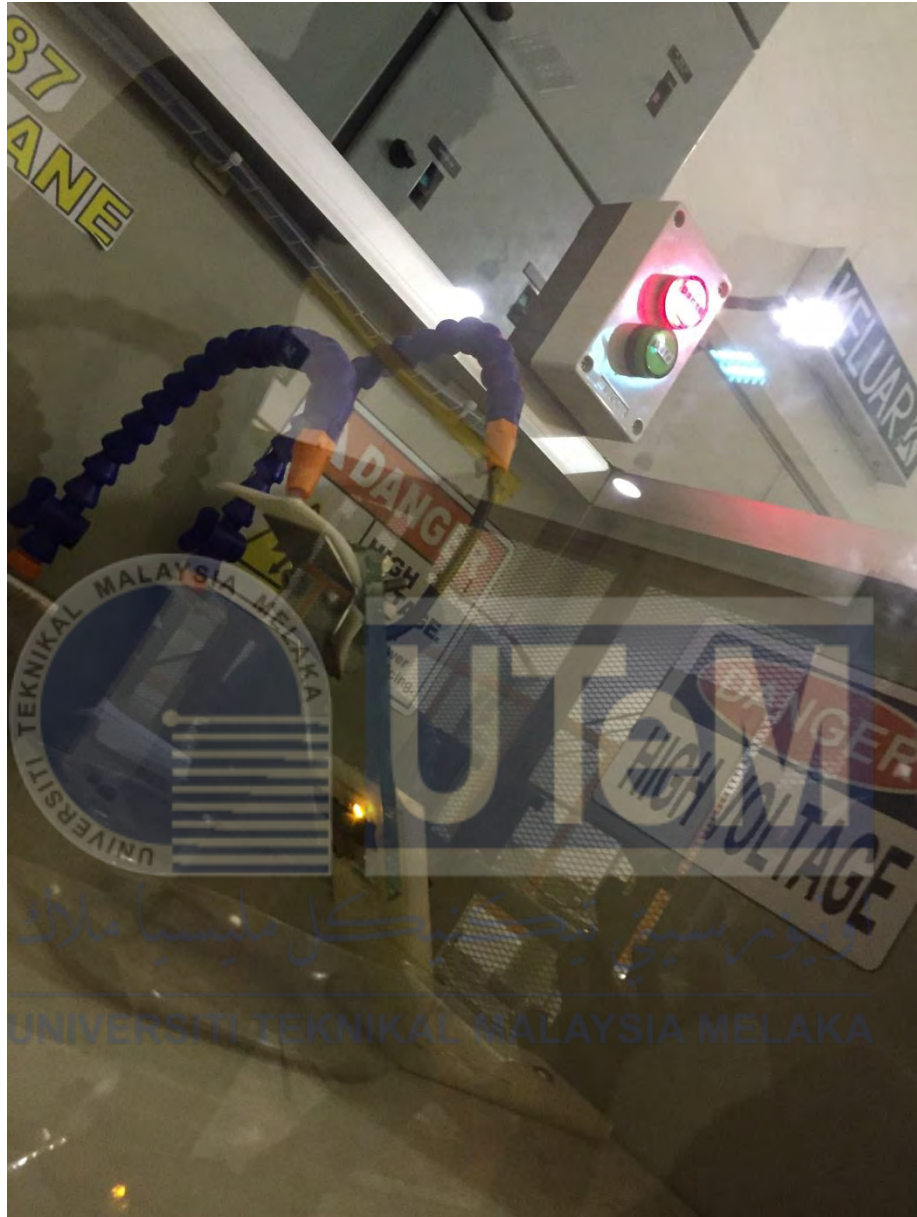
Figure B : Glass specimen ongoing test
