UNIVERSITI TEKNIKAL MALAYSIA MELAKA

**RAILWAY CRACK DETECTION SYSTEM USING
ULTRASONIC SENSORS AND ARDUINO UNO**

This report submitted in accordance with requirement of the Universiti Teknikal Malaysia Melaka (UTeM) for the Bachelor's Degree in Electronics Engineering Technology (Industrial Electronics) with Honours

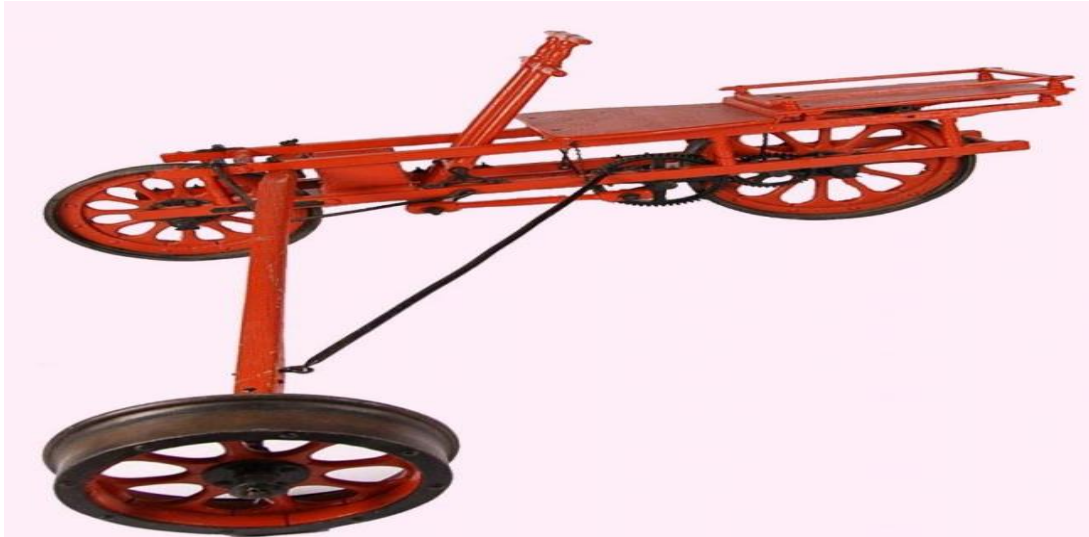
Figure 2.3: The 3-wheeled Velocipede Hand Car

The 3-wheeled Velocipede Hand Car became popular and applied on American railroads during the 1880's. It was specially refashioned for the use of Road Masters, Bridge Inspectors, Telegraph Line Repairers, and Crosstie Inspectors. However, the Velocipede was convenient for all types of rail work where one or two men wished to go over the line at will. Velocipedes were mainly used by railway officials to personally check the portions of the line that came under their direct authority. The Velocipede permitted the official to stop wherever men were at work, giving them direction and paying attention to crack in form of defects he had noted during his journey. In this way, his section of railroad would be assured of being maintain in the best possible condition. The Velocipede is propelled by one person and has a seating capacity for two, allowing the driver or inspector to bring along an extra

section hand or another official. The vehicle is adjusted into motion by a rowing motion and auxiliary, foot pedal-power. The frame, wheels and outrigger are made of white ash, the frame are being firmly held together by bolts. The outrigger is stiffened by an iron brace. The tires are cast iron, the axles and crank shaft are iron, and the crank and pedals are made of malleable iron.
