**UNIVERSITI TEKNIKAL MALAYSIA MELAKA**

**EXPERIMENTAL INVESTIGATION OF REAR SPROCKET  
FAILURE OF A FIXED BICYCLE USING ACOUSTIC  
EMISSION AND VIBRATION ANALYSIS**

This report is submitted in accordance with the requirement of Universiti Teknikal Malaysia Melaka (UTeM) for the Bachelor of Mechanical Engineering Technology (Maintenance Technology) with Honours.

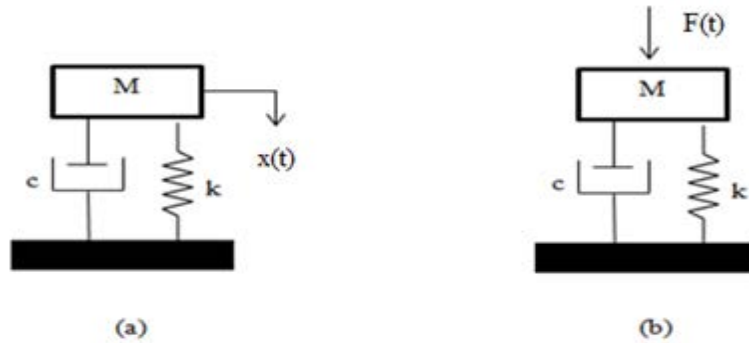
Figure 1.1: Free vibration (a) and forced vibration (b) with damping

In terms of engineering, vibration can be defined as a self-repeated motion or oscillation that occurs on mechanical system from its position of rest under an interval of time (de Silva, 2000). Basically, vibrations are divided with two types which are free vibration and forced vibration. Free vibration is the process that occurs when some system or equipment is setup with initial force and then let it vibrate freely for example the motion of pendulum, plucking a guitar string, blow over the top of bottle and etc. These systems are tending to vibrate at a certain frequency which also known as natural frequency. Forced vibration is occurring when force or motion is applied to object and vibrate at a particular frequency and the example of this type of vibration is vehicle engine, mechanical equipment (turbine, air compressor) and building vibration during earthquake happen (Bradford, 2012)

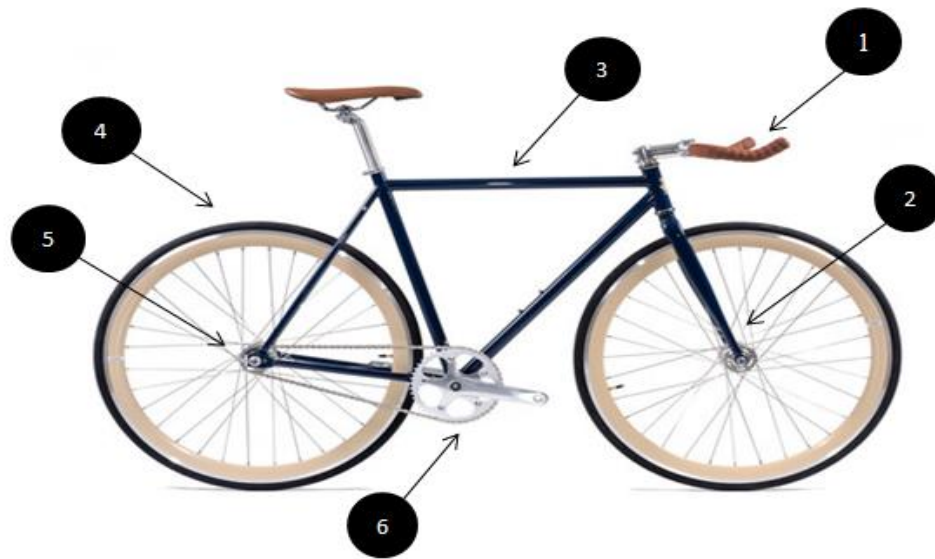
Figure 1.2: Fixed bicycle part; 1.Steering 2.fork 3.frame 4.wheel 5.rear sprocket 6.front sprocket (State Bicycle, 2016)

Nowadays, bicycle is not only being used for recreation or exercises but also for awareness of environmental protection (Liu et al. 2013). Due to its ability to reduce traffic jam within the cities, people are more attracted to cycling. It provides more economic than use other vehicle as a transport because no need to use fuel to move. The important aspect that should be emphasized by manufacturer is the user comfort and safety especially on new infrastructure of pathways today (Hölzel et al. 2012). Bicycle manufacturer should provide safety and comfort for the user on their product. The bicycle structure must be high quality in terms of strength and endurance to avoid from damage due to external loads. The suspension system also must be effective enough to decrease the level of disturbance when user through the rough road so it gives comforts to user. Many researchers are studies about cycling comfort such as comfort level of bicycle on different surface, effect of surface road condition on bicycle comfort, relation of dynamic characteristic of bicycle to the comfort level and etc. (Ismail et al. 2015). Bicycle has a very complicated system than other vehicle such as car and motorcycle because it involves more than 2000 component. Existing components on the bicycle can be divided by several subsystems which are frame, wheel, steering, fork and gear/sprocket (Mao and Chen, 2009).

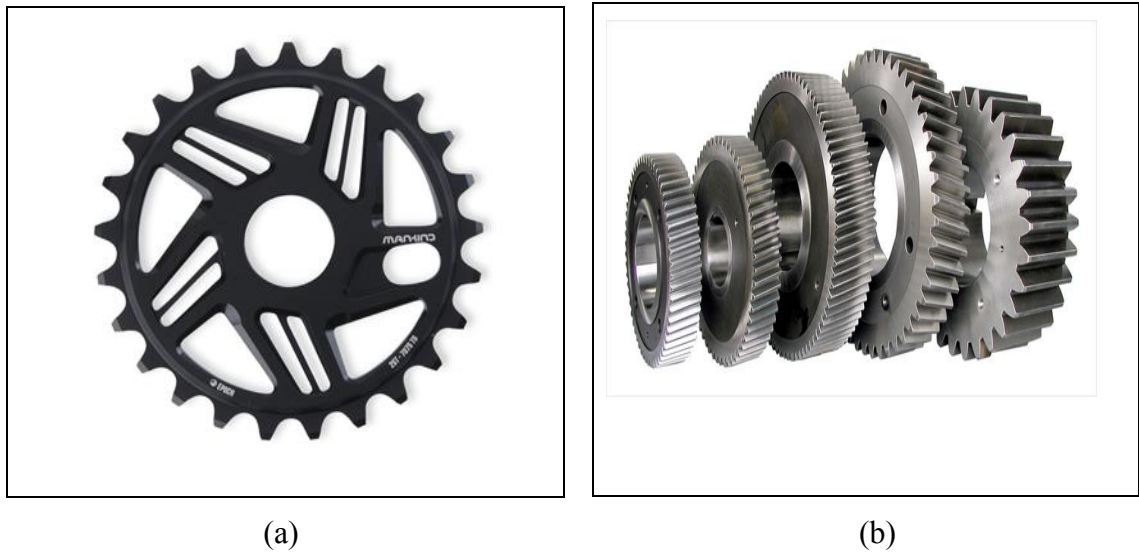
Figure 1.3: Sprocket (a) and Gear (b) (Mankind Bike, 2016 and Shanti Gears, 2015)

Sprocket is a toothed wheel designed that used in the drive systems of machinery. The main function of sprocket is to engage and directly move the chain or belt. These mechanical parts are widely used in bicycles, motorcycles, movie projector, tanks and conveyor belt which to transmit rotary motion from one shaft to another. In manufacturing, the sprocket goes through heat treatment process to improve their

hardness so that the lifespan of sprocket increased. Today, many engineers either technologist is trying to develop a manufacturing process for more complicated sprocket shape by upgrading their fabrication efficiency. As a result, both gear and sprocket are quite different application. However, the main objective is similar which is to transmit power between two shafts (Thipprakmas, 2011).

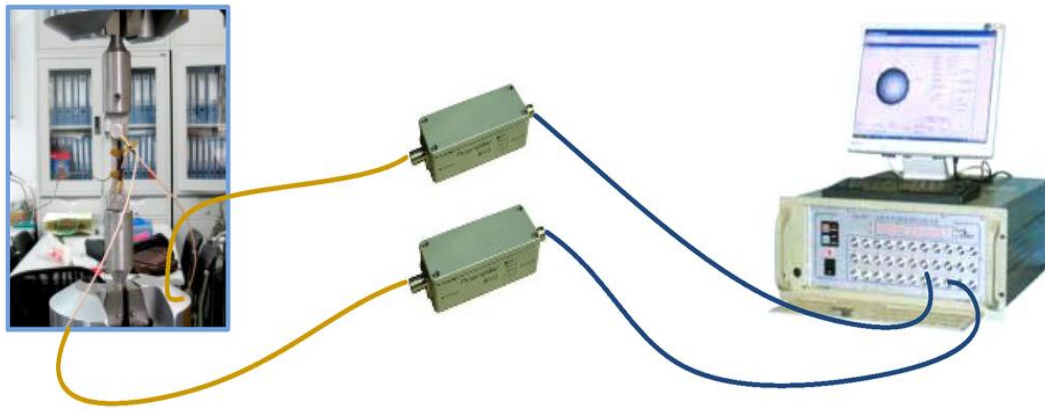
Figure 1.4: Investigation of Material Performance Degradation for High-Strength Aluminum Alloy Using Acoustic Emission Method (Ai, 2015)
