**CORROSION MONITORING OF GALVANIZED STEEL UNDER CHLORIDE  
RICH ENVIRONMENT USING POTENTIOSTAT TESTING**

**This report is submitted  
in fulfilment of the requirements for the degree of  
Bachelor of Mechanical Engineering**

**UNIVERSITI TEKNIKAL MALAYSIA MELAKA**

**2021**

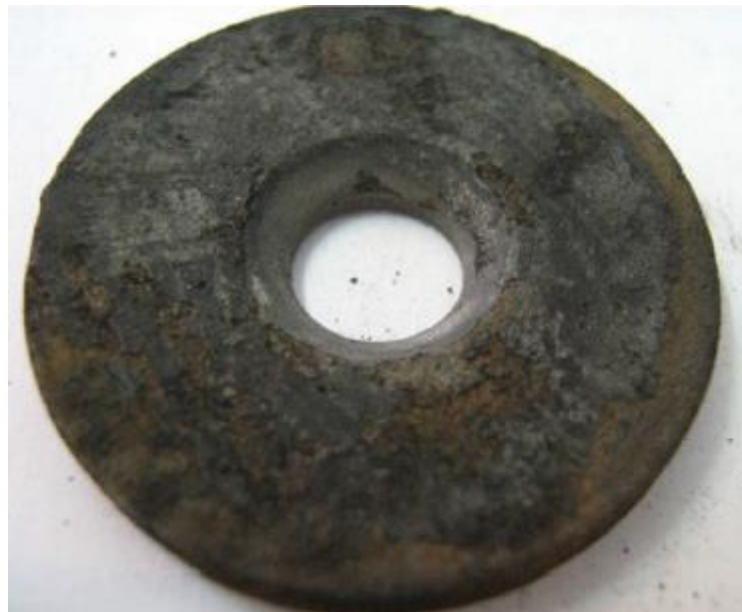
not possible to differentiate between anodes or cathodes that randomly emerging because of the electrochemical process. The most common example of uniform is iron rusting which occurs as a result of oxidation of the iron metal. Figure 2.1 shows the uniform corrosion on the disc coupon that was used in the study by Mansoori et al. (2017). This study is to monitored the uniform corrosion internal part of wet gas pipelines. The coupons were in service for 3 to 6 months at the wellhead facilities and then were recovered for weight-loss testing.

Figure 2.1: Uniform corrosion on disc coupon (Mansoori et al., 2017)

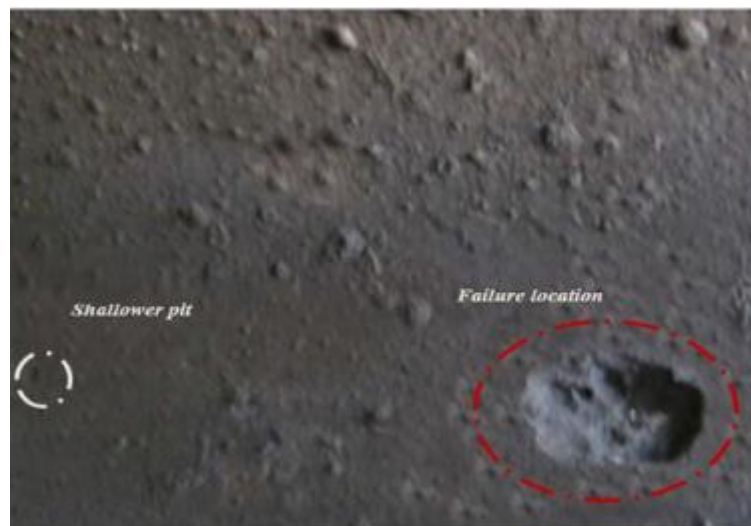
perforate the metal surface. Therefore, continuous pitting corrosion monitoring is extremely important for the integrity of the metal. Similar study by Mansoori et al. (2017), showing that the pitting corrosion found at the internal surface of a wet gas pipeline as shown in Figure 2.2. The failure location is marked in the main pit that occurs on the surface of the pipe and the shallower pit is located near the main pit.

Figure 2.2: Pitting corrosion at internal surface of pipeline (Mansoori et al., 2017)
