**A SURFACE TOPOGRAPHY STUDY OF THE UNTREATED AND
HEAT-TREATED ZIRCONIA DENTAL CROWNS
MANUFACTURED THROUGH CNC DENTAL MILLING MACHINE**

This report is submitted in accordance with requirement of the Universiti Teknikal
Malaysia Melaka (UTeM) for Bachelor Degree of Manufacturing Engineering (Hons.)

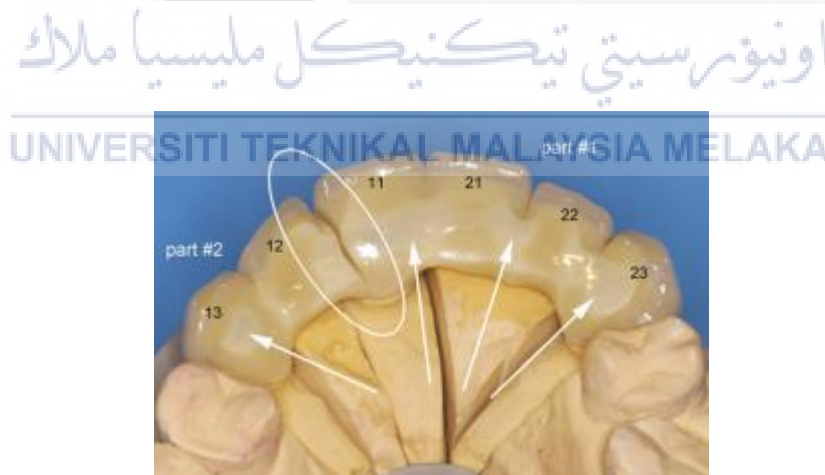
Figure 2.3: Cercon veneered six-unit anterior Zirconia bridge (Lohbauer *et al.*, 2010).

A dental clinician provided a 24 h in vivo anterior fractured (canine to canine) six-unit fixed partial dentures (FPD). A dental technician in a private laboratory that trained in CAD/CAM techniques and handling Cercon System for the Zirconia framework had manufacture the Zirconia The frame of the Cercon consisted of a Y-TZP sintered with 1350°C and furnished with a porcelain feldspar. According to the dentist, the frame was manually modified by remolding the palatal surface after CAD/CAM machining (Lohbauer *et al.*, 2010). Figure 2.3 shows the anterior Zirconia bridge manufactured from Cercon System.
