**A SURFACE TOPOGRAPHY STUDY OF THE UNTREATED AND
HEAT-TREATED ZIRCONIA DENTAL CROWNS
MANUFACTURED THROUGH CNC DENTAL MILLING MACHINE**

This report is submitted in accordance with requirement of the Universiti Teknikal
Malaysia Melaka (UTeM) for Bachelor Degree of Manufacturing Engineering (Hons.)

FACULTY OF MANUFACTURING ENGINEERING

2021

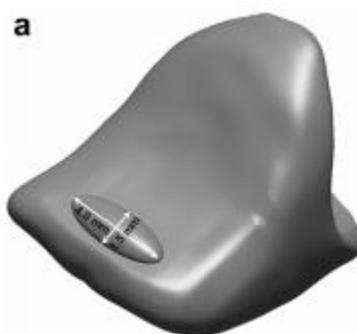
Figure 2.5: CAD-constructed maxillary incisor crown with the modified area (raised ellipsoid) on the oral side (Schmitter *et al.*, 2014).

Schmitter *et al.* (2014) have discussed the Zirconia veneer was developed with commercial dental software CAD/CAM (Dental Designer; 3Shape, Copenhagen, Denmark) and modified at the edge of the incisor. Performing two modifications, which is, the oral part of the veneer beneath the edge of the incisor was made planar and subsequently, an ellipsoidal bump (4mm× 1.5mm× 0.5mm) was placed at the location of the planned load application point (Schmitter *et al.*, 2014). The CAD-constructed maxillary incisor crown is shown in Figure 2.5.

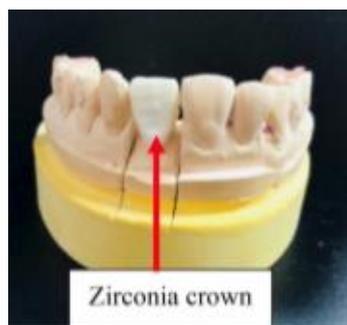
Figure 2.8: CAD/CAM milled Zirconia crown (Faeizah *et al.*, 2019).

Yttria-stabilized Zirconia was used in order to fabricate the Zirconia block. A five-axis open system CAM (Dentaswiss, Biodenta, Germany) milling machine was used to machine the Zirconia blocks into a crown frame. The Zirconia blocks were conducted for the sintering process between 900-1200°C with 2 hours holding time and the cooling rate at 3°C/min. Figure 2.8 shows the milled Zirconia crown restoration. After the machining process, a FESEM (Zeiss Merlin) Field Emissions electron Microscope observed the morphological characteristics of milled zirconium surfaces to evaluate the effect of zirconium surface quality pre-sintering temperature (Faeizah *et al.*, 2019).

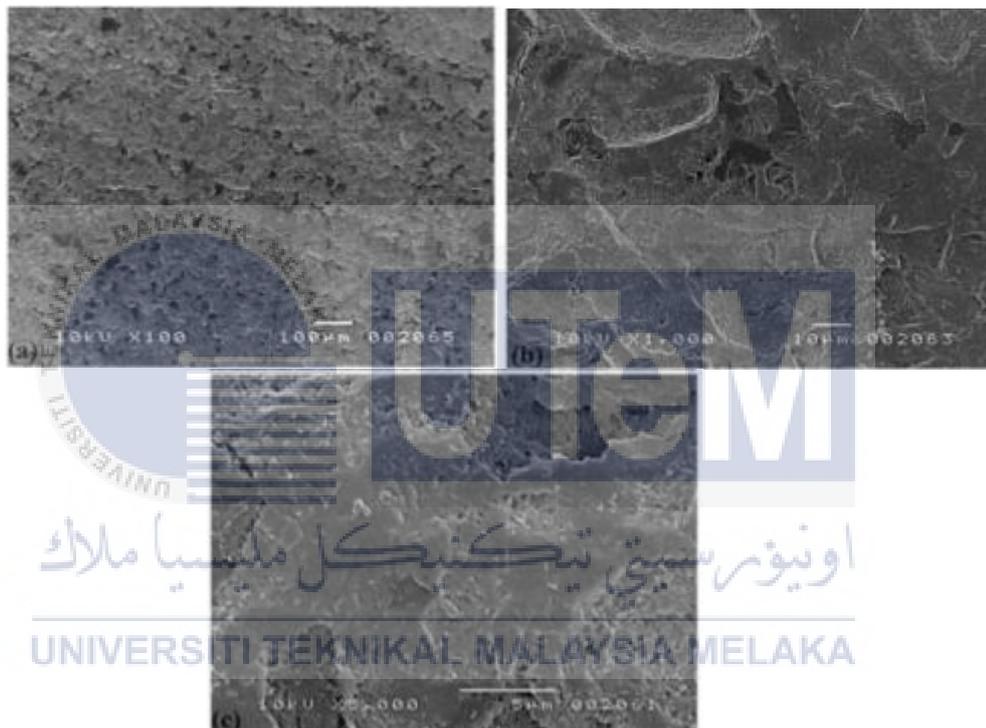
Figure 2.16: SEM LMGC Surface micrographs produced by the CAD/CAM process reveal (a) fractional fracturing tracks, fractures and pile-ups induced with the shear band to pulverize material (100x magnification), (b) surface fracture details (1000x magnification), and (c) pulverized and smeared area details (5000x magnification) (Alao *et al.*, 2017).

Alao *et al.* (2017) discussed the specimens were gold coated before the topography analysis. In order to study surface fracture, morphology and removal mechanisms, each surface processed was also seen under SEM (JEOL JSM 5410LV, Tokyo, Japan) with 10kV accelerating voltage. The CAD/CAM-milled LMGC morphology is shown in Figure 2.16(a), which is the details of machining grooves and scratched due to the diamond abrasives. Figure 2.16(b) shows the effect of the shear bands that cause the cracks and irregular fractures and also smeared areas on the surface. The pulverized areas accumulated with the microchips tested on the highly fractured areas are shown in Figure 2.16(c).

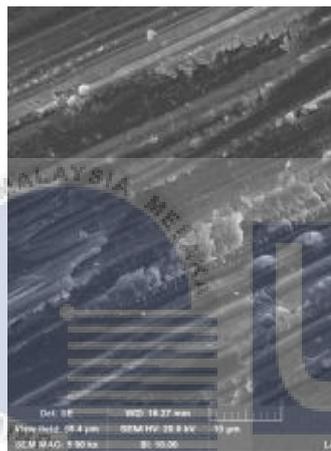
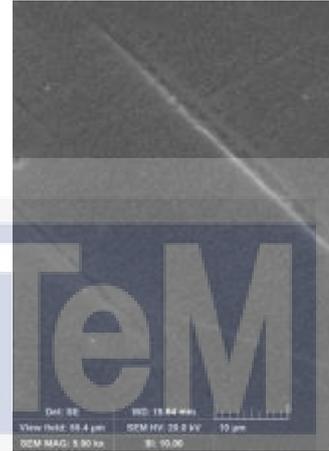
(a) Sintered

(b) Grinding

(c) Grinding+heat treatment

(d) Grinding+polishing

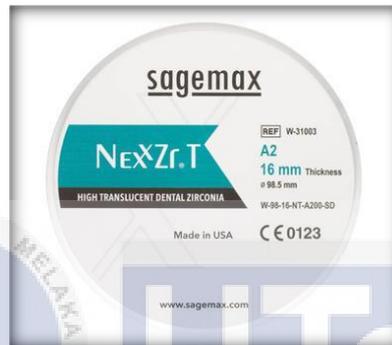
Figure 3.4: NexxZr T, dental Zirconia oxide (Y-TZP ZrO₂) from Sagemax Bioceramics, Inc.

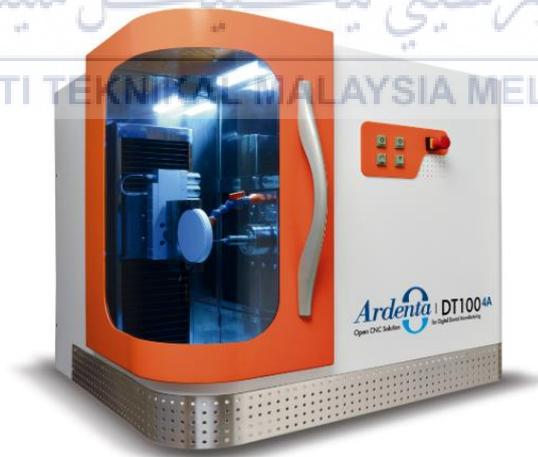
Figure 3.5: ARDENTA DT 100 dental CNC milling machine.

ARDENTA has a horizontal spindle that is capable of providing good control of the chip and great precision. This machine has 0.001 mm location resolution and an accuracy of 0.01 mm positioning. ARDENTA has a minimum margin thickness of 0.15 mm while a minimum coping thickness is 0.3 mm and a cement gap of 0.02 mm. From 'ARDENTA.pdf' article (n.d.), ARDENTA is the laboratory-oriented CNC controller with its own features such as a simple one-touch graphical interface, which allows the operator to use without CNC experience or training, and process automation is complete due to the measuring system for tool lengths. ARDENTA also has 4 or 5-axis milling machines with high precision and speed.

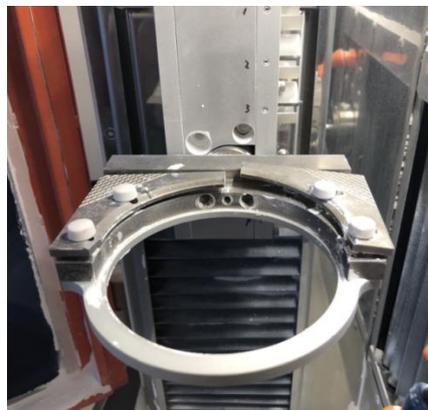
Figure 3.9: Material platform.

The Zirconia blocks must be attached and locked on the material platform, as shown in Figure 3.9. The material needs to be locked to ensure the workpiece is not moving during the machining. The machine needs to be monitored during machining is in progress to prevent the failure of the tool during the machining. After the machining is done, the machine stops automatically. After that, the user just needs to open the door of the machine and pick up the crowns and keep it under room temperature in order to avoid the environmental temperature affects the samples during the topography analysis. The crowns are wrapped with a fabric or tissue in order to avoid the cracks due to the brittleness of Zirconia. Figure 3.10 shows the Zirconia blocks after the crowns were manufactured.

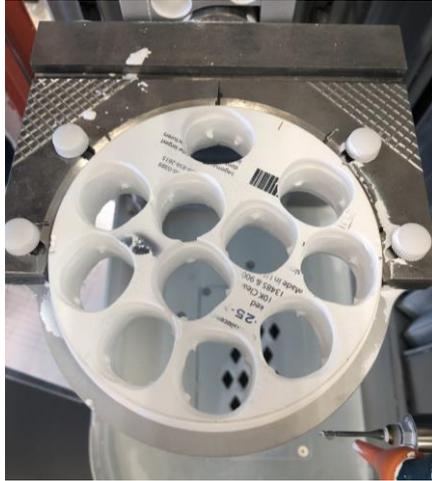
Figure 3.10: Zirconia block after machining.

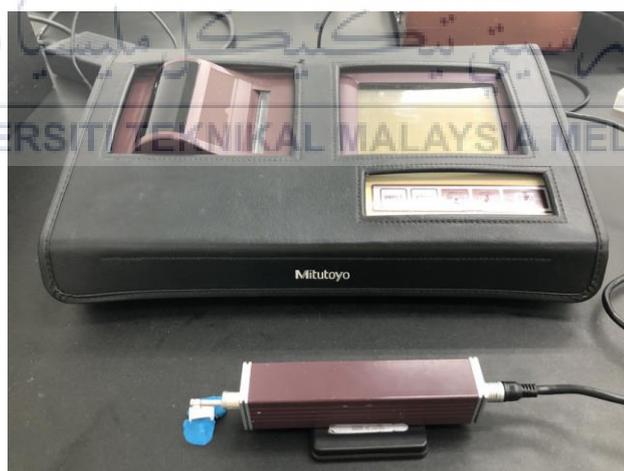
Figure 3.13: Mitutoyo Surftest SJ-410 surface roughness tester at Metrology Laboratory.

Mitutoyo Surftest SJ-410, which is a profilometer, was used to measure the surface, as shown in Figure 3.13. The setup that is crucial in this analysis is the travel length that set up, which 0.08 mm x 3 due to the surface of the dental crown is small and limited. The experiment was repeated several times because of the limitation of the machine that only can yield the measurement on the flat surface. During this study, there are four conditions of the crowns which are untreated, 850°C heat treated, 950°C heat-treated, and 1050°C heat treated. The measurement was carried out using two samples from each condition of the crowns.

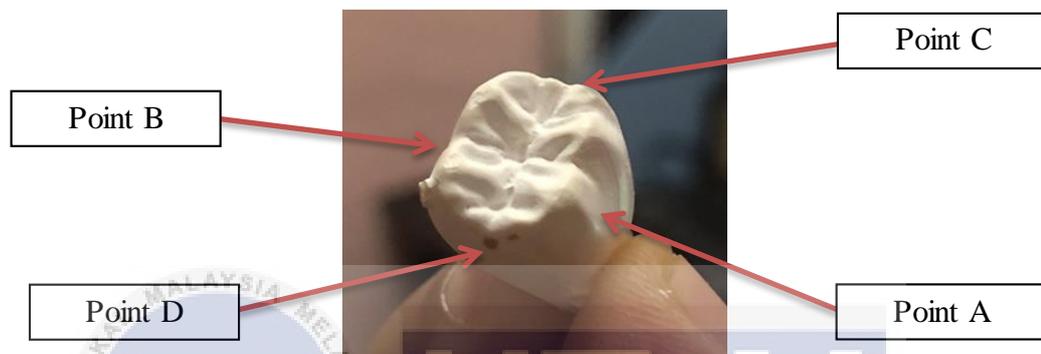
Figure 3.15: Measurement area on each side of the crowns.

average of the absolute values of the height deviations which is from the mean line. In other words, the Ra value is the average of a set of individual measurements of a surface valley and peak. To make sure the Ra measurement is done on the same side for all of the samples, the selected points are initially marked to avoid the measurement error. The results of the measurement can be stored, written, extracted as SPC data and transmitted to a personal computer. The selected samples, which are two samples from each condition, were employed for this test.

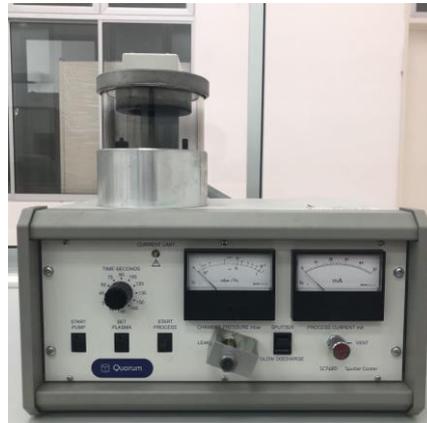
Figure 3.17: SC 7620 Mini Sputter Coater at the laboratory.

in Figure 3.17. The powder coat is required to create a conductive layer of metal on the sample, inhibit charging, minimize thermal damage, and improve the secondary electron signal required for topographic analysis in the SEM.

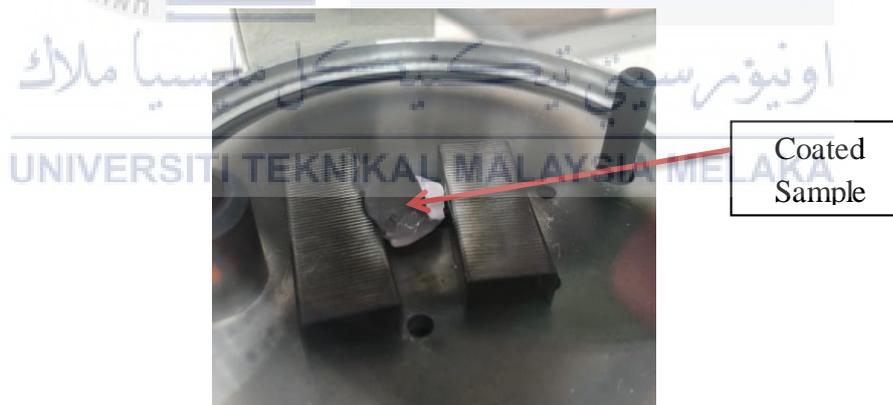
Figure 3.18: Crown sample after the coating process.

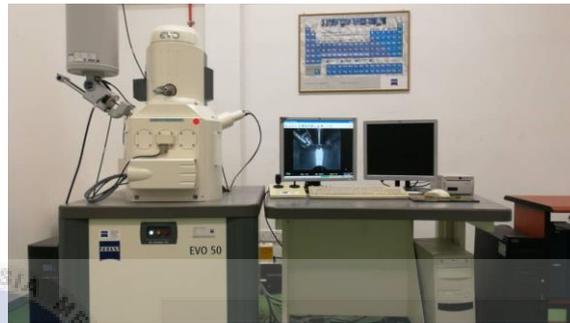
Figure 3.19: Carl Zeiss Evo 50 SEM Machine at FTKMP laboratory.

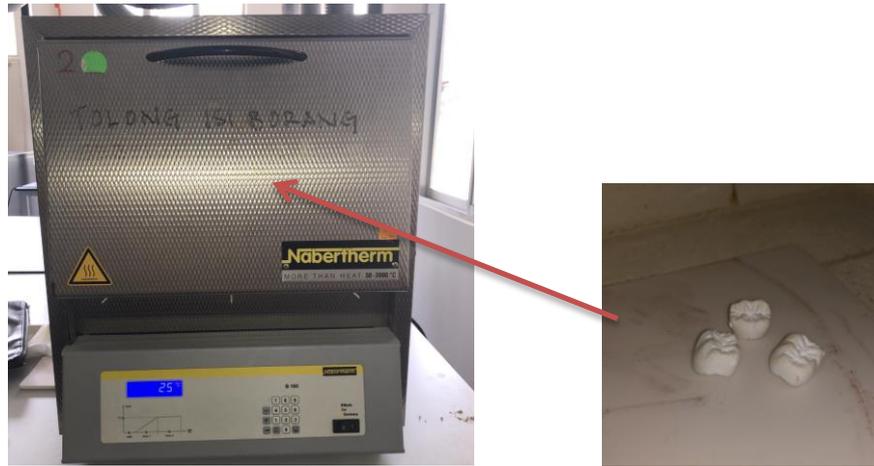
Figure 4.1: Sample set up for a batch of heat-treated samples.
