**DEVELOPMENT OF WATER LEAKAGE DETECTION OF HOUSE
PIPE SYSTEM**

Bachelor of Computer Engineering Technology (Computer Systems) with Honours

**A project report submitted
in partial fulfillment of the requirements for the degree of
Bachelor of Computer Engineering Technology (Computer Systems) with Honours**

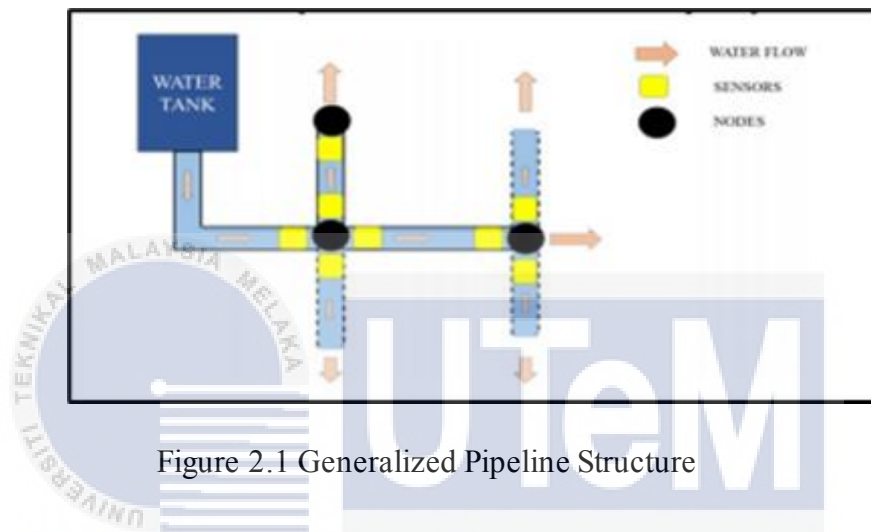
Figure 2.1 Generalized Pipeline Structure

Figure 2.1 shows the pipeline structure, which includes several branches and nodes. Such a structure may be broken down into its essential components: two units and three nodes [3]. The microcontroller is placed from the sensor placed at each sub-pipe adjacent at the point more pipes branch. The flow sensor will be attached to the microcontroller to collect the data of flow rate.

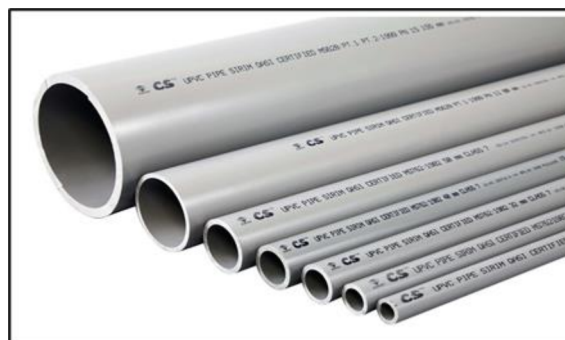
Figure 2.2 PVC Pipes

Figure 2.2 shows PVC pipe is the most commonly used for draining and vent lines. It has become popular and well-known as a result of its lightweight and ease of use.

Galvanized steel pipe is more difficult to deal with than PVC pipe. It is also quite simple to put together and cut into parts for our purposes. It is simple to glue PVC pipes together, and all that is required is a solvent.

PVC is a low-cost material that used for a long time. Before purchasing a pipe, check the diameter listed on the pipe's surface. PVC cannot be un-connected after it has been connecting, so we will have to cut it. PVC pipes that have been glue together are occasionally prone to leaking.

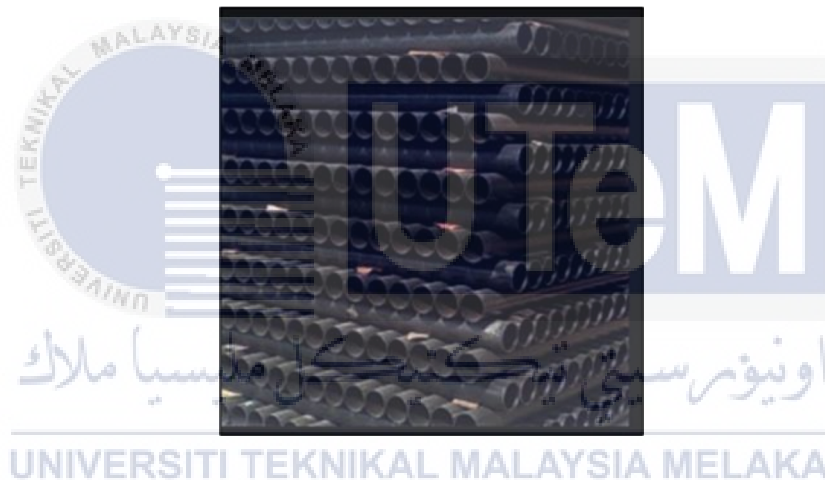
Figure 2.3 Cast Iron Pipes

These plumbing pipes are pricey and have threaded connections. Cast iron pipes are heavier than PVC and other conduits, making them ideal for a water distribution system underground. Because of its robustness and extended life, cast iron pipe makes up most municipal pipelines, as Figure 2.3. Pipes made of cast iron can be utilized until they corrode entirely. These pipes are extremely tough to resize and cut. They are primarily used for gas distribution, drainage, and water distribution. On the other hand, ductile iron pipes have the advantage of a clean tapping procedure utilizing specialist tools, which lowers the need for welding and installation abilities [20].

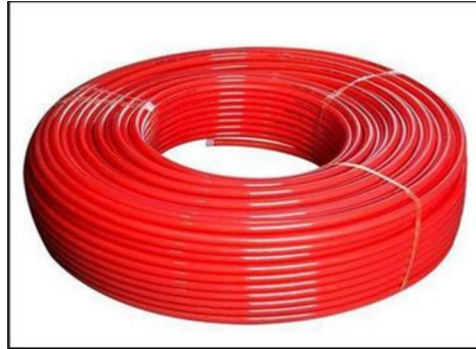
Figure 2.4 PEX Pipe

PEX pipe is a new product on the market, as well as in the plumbing industry. It is purely for water supply. PEX pipe has the benefit of being stiff and durable. It can withstand water pressure. Because it is flexible, it can weave around walls and crawl spaces.

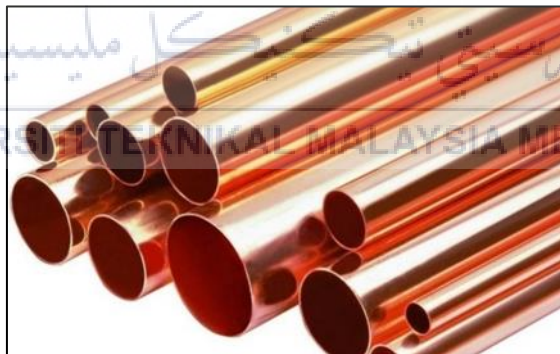
Figure 2.5 Rigid Copper Pipe

Within the home, rigid copper pipe is typically utilized for water supply lines. It is pretty simple to cut. With a hacksaw, it is possible to cut it. A stiff copper pipe connection differs from others in that soldering copper pipes together takes practice. It has no dangerous precautions and is suitable for water supply. The pipe is flexible despite its rigidity. It can tolerate high temperatures and pressure.

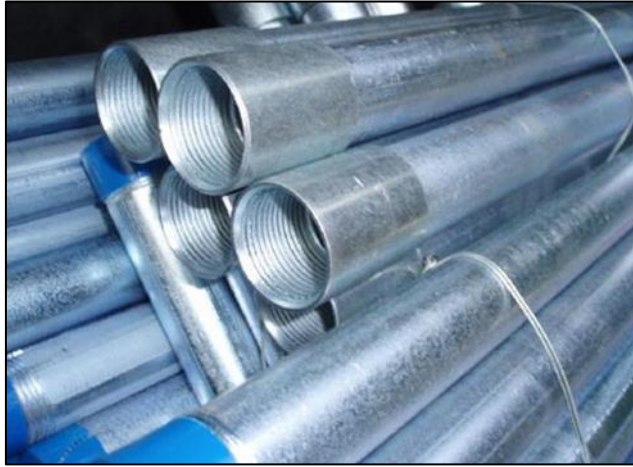
Figure 2.6 Galvanized Steel Pipe

For many years, galvanized steel pipe has been utilized for drainage, water delivery, and gas delivery. It can also be used for other things. However, it is rarely employed in the present era, notably for water delivery in new residences. The threaded ends of the galvanized steel pipes are screwed together using joints. These pipes are pretty durable, but they can corrode and obstruct water flow.
