# CHARACTERIZATION OF BIAXIALLY ORIENTED POLYPROPYLENE (BOPP) FILMS CONTAINING BAGGY WEB DEFECT

This report is submitted in accordance with requirement of the University Teknikal Malaysia Melaka (UTeM) for Bachelor Degree of Manufacturing Engineering (Hons.)

Tajuk PSM: Characterization of Biaxially Oriented Polypropylene (BOPP) Films Containing Baggy Web Defect Nama Syarikat: San Miguel Yamamura Plastic Film Sdn. Bhd.

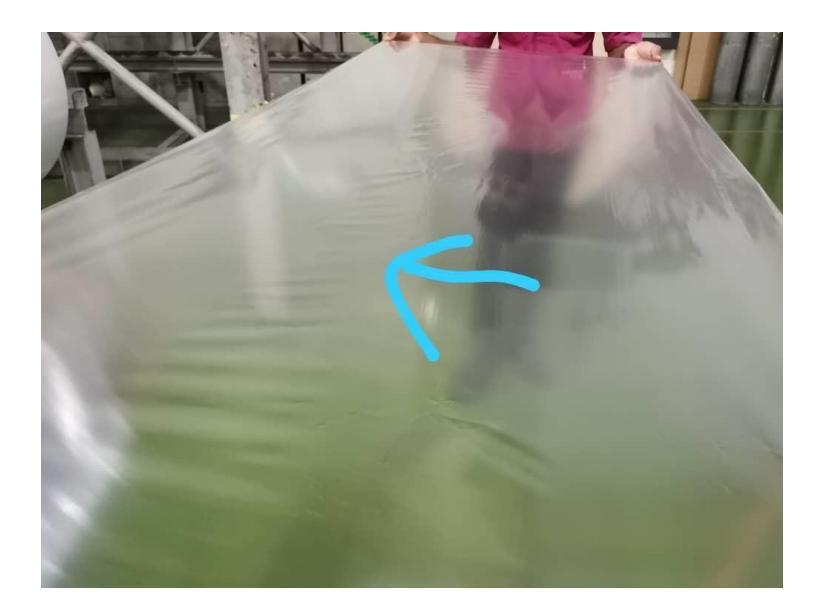
Figure 1.1: Baggy web defect on BOPP films.

Based on the information provided by SMYPF, surface defects such as baggy web can be detected on BOPP films after the slitting process. SYMPF manufactured 24kilometre-long BOPP films that will be slitted into three sheets of 8 kilometer wide. Only at the third slitted plastic films, which is the final slitting operation, will these faults appear. Figure 1.1 displays a web with a cross web variation in machine direction length produced by SMYPF. Some of the areas indicated out by the arrow were impacted by the baggy web issue.

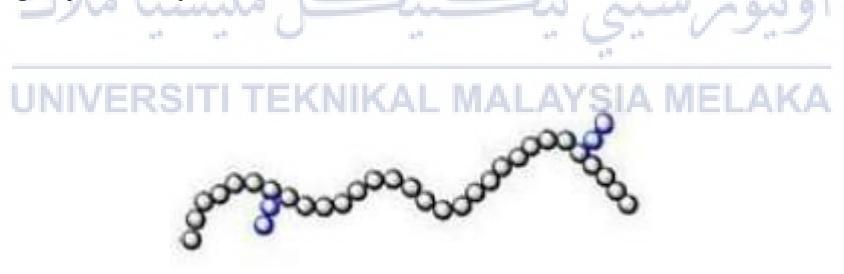
Figure 2.1: HDPE structure ( $C_2 H_4$ ) (Graziano et al., 2019).

HDPE is made using a low-pressure process, and it has the highest degree of crystallinity and is the most flexible of all the PEs. It is also the most stable PE because it has fewer short branches, which means the chains pack very tightly into the crystal structure, as shown in Figure 2.1 (Graziano et al., 2019). HDPE is used most commonly in hard packaging, such as milk bottles and household chemicals (Emblem, 2012). HDPE offers a moisture barrier and is commonly used in the packaging of dry goods due to its characteristics (Butler & Morris, 2016). HDPE offers the highest oil resistance because to its strong crystallinity.

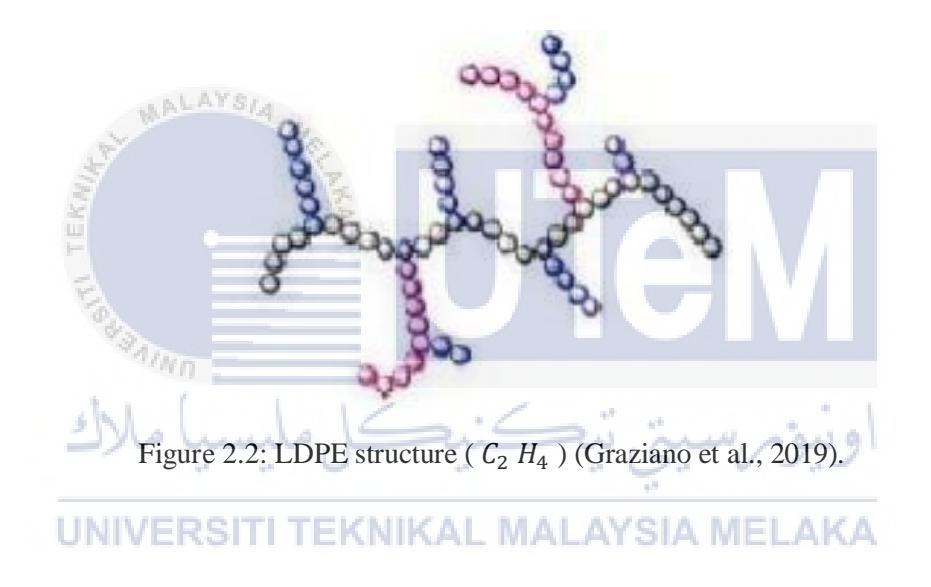
Because HDPE is made using a low-pressure technique, LDPE is made using a highpressure method and contains both short and long branching chains, as well as roughly 50-65 percent crystallinity, giving it a clear look as illustrated in Figure 2.2. LDPE is extensively utilized as a vital packaging material because of its great qualities, such as high elasticity, impact strength, and chemical resistance. (Butler & Morris, 2016) It also has a good moisture barrier but a weak oxygen barrier and softens at roughly 100°C (may be lower for some grades, depending on the polymer resin grades), making it a cost-effective polymer to process and heat seal, but unsuitable for cook-in packs (Emblem, 2012).
