Fencing Improvement at Palm Oil Mill to Reduce Costly Waste

Thesis submitted in accordance with the partial requirements of the
Universiti Teknikal Malaysia Melaka for the
Bachelor of Manufacturing Engineering (Manufacturing Process)

FENCING IMPROVEMENT TO REDUCE WASTE AT
PALM OIL MILL

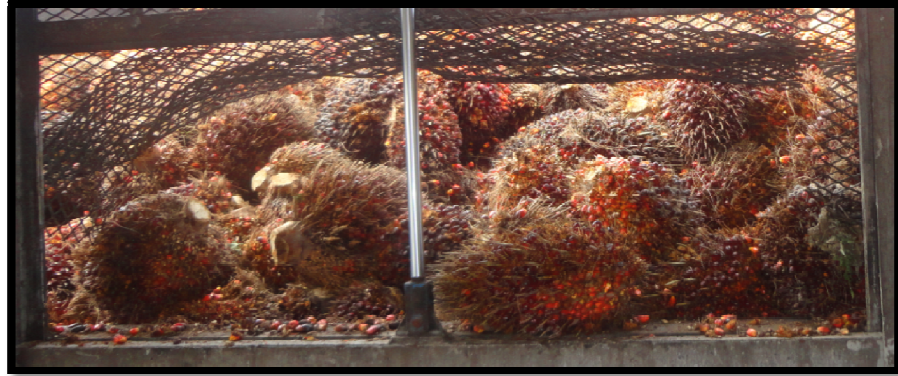
Fencing of the ramp at the FFB reception station need to be repaired and replace. The flat barricade door at the bottom portion of fencing is powered by hydraulic power and is controlled by a worker at a time. As the time passed, the fencing act as a barricade to hold against the palm oil fruit is swollen, expanded and broken. The fencing is suspected to be a failure due to impact force by the FFB that falling into the ramp but the investigation has been carried out to determine whether the material is failure before or after the being hit by FFB.

Initial inference stated that the fencing might come into failure due to material failure or design failure or both. However, after the observation has been made on the surface of the fencing there are brownish color surface appear on the surface of fencing which is known to be rusty. A corrosion phenomenon has always been a nightmare in the industrial environment, especially when it involved with delaying processing time as it absolutely affecting the quality of a product later. Design of a product gives a great impact on product to carry out their task upon given application. A product is a failure when it cannot achieve its service life when it is expected to be.

Figure 1.0: Fencing failure at reception station

Due to this situation, when the fencing comes into failure, the flat barricade door is stuck under the expanded fencing failure when worker in charge undergoes their duty to release the FFB from the ramp. As a result there is a delay time of operation at that station which contributes to high lead time for a process station. As the barricade door doesn't open the fruit cannot be released and the worker needs to manually pull out the fruit out of the cage. The station has more than one barricade door so this problem may not seem as a huge matter so the process still can be proceed as long as there is another functional barricade door but the station with damage flat barricade door cannot proceed along the FFB will remain there until a maintenance worker fix the fence. While waiting the fencing getting fixed at the end of the week the quality of fruit decrease as the FFB processing period prolonged. The free fatty acid content is higher for late process of FFB. In addition there is several waste identified along with the problem such as energy waste, time waste, waiting waste, talent waste and transportation waste.
